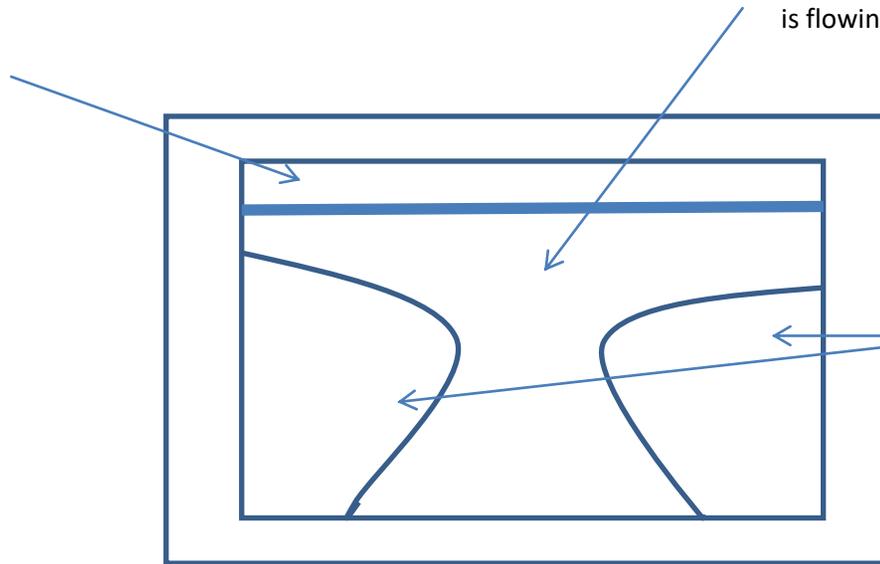
For lack of better term I define this as a manifold, the area between the glass and angled steel plate; this is the air feed

The area between the stains represents where the air is flowing into the system

Stain areas; size is function of air velocity. When air velocity is low air wash does not reach the outer edges of glass

In my case when stain pattern does not enter the manifold (above illustration) there are no gases exiting the stove at door (No Smell)

Note the stain patterns are not at the same height; this is related to uneven air velocity between left and right sides possibly caused by air path disturbances around temperature control flapper creating turbulence and uneven flow at the horizontal distribution manifold located at the back of the stove

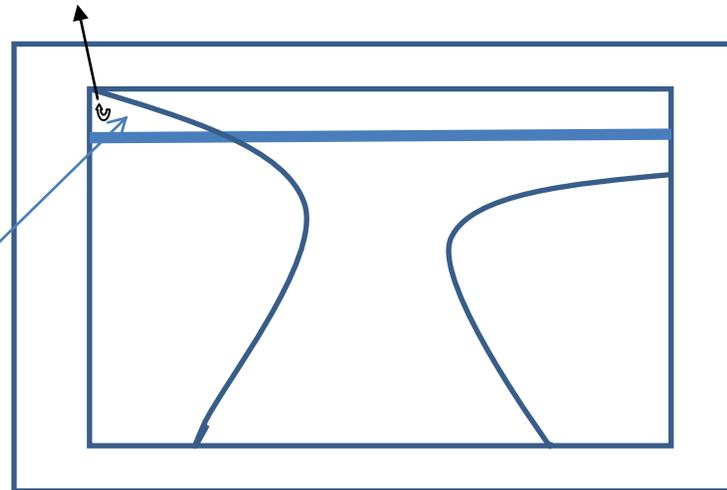
Gases forced out

Stain pattern (represents fuel) enters the manifold; oxygen allows combustion and some type of vortex / localized pressure is created. Gases forced out through gasket most likely due to fuel combustion and expansion in the manifold

When stain pattern enters the manifold gases are exiting the stove (Smell). The stain approaches the manifold when air velocity is low, contrary to popular believe this can happen when the temperature control is set to HI. Regardless where the temp control is set if the BTU demand is less than the available BTU the thermostat flapper closes, stack temperature lowers, and velocity is low causing the logs to smolder at which time the off gases are circulating around the corners of the manifold
