Masonry chimney with two flues; one for the Lopi Endeavor free standing wood stove and one unused which originates in the basement.

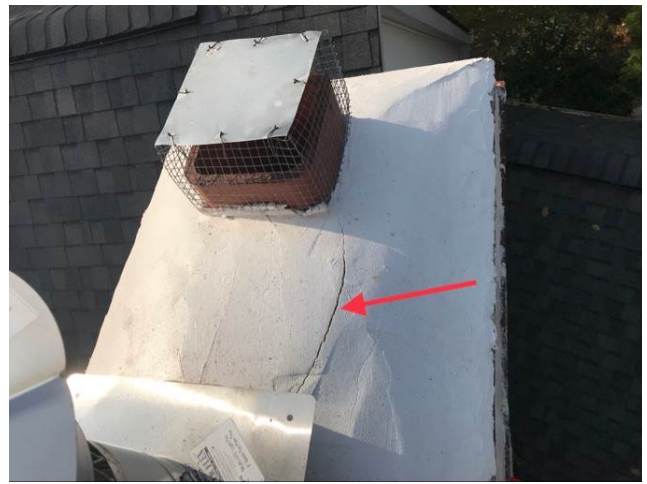
1. There is no expansion joint around the top flue tiles. An expansion joint is to allow the chimney flue to expand and contract without causing damage to the masonry material on top of the chimney. As a result, cracks have formed in the masonry. This will cause the chimney to deteriorate until repaired.

Crack in mortar

- Recommended repairs to the exterior include:
- Scaffolding setup and chimney access
  - Fill in large crack on top of chimney
  - Apply flexible crown sealant to top of chimney
  - Installation of chimney cap with large lid that overhangs entire chimney

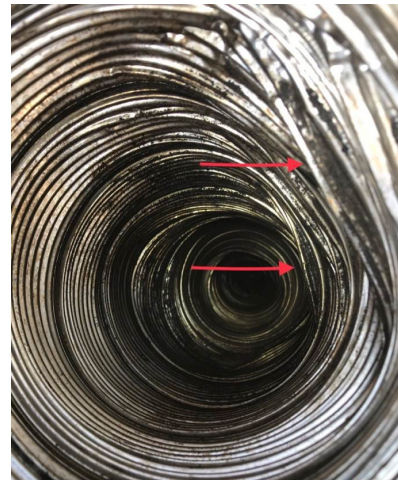
2. The stainless steel liner is bent and damaged near the top of the chimney. The liner is also bent where two pieces of liner have been connected. While using a coupler to join multiple sections of liner is allowed, having damage to the liner in these areas can allow heat, smoke and soot to escape the liner.

Damaged liner near top of chimney

- Recommended repairs for the wood stove include:
- Obtain any required permits for installation
  - Scaffolding setup and chimney access
  - Removal and disposal of the existing stainless steel lining system
  - Removal and disposal of clay chimney flue liner
  - Installation of a fully insulated stainless steel lining system

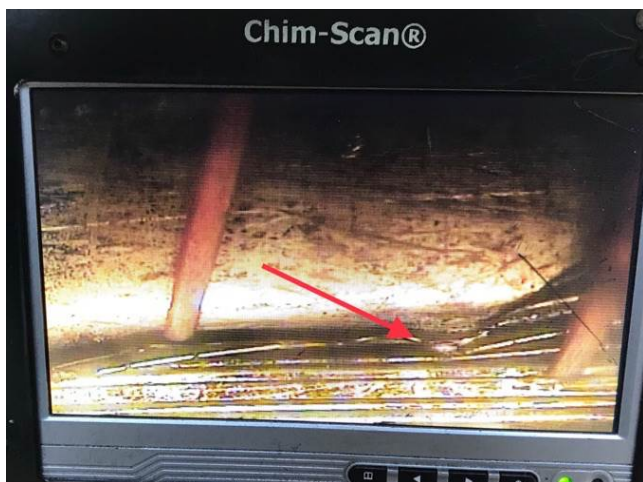
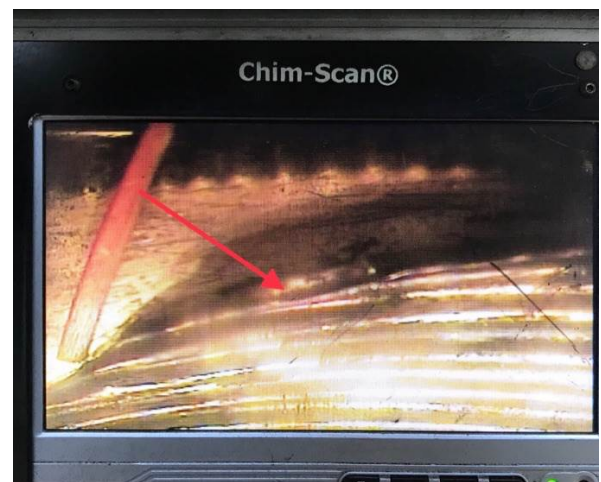
Damaged liner at coupler
