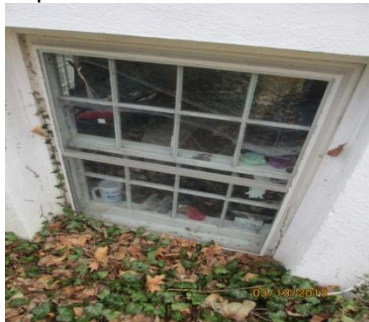
Storm window with cobwebs. Also sets at grade.

- There are cobwebs and spider webs located between the outer storm windows and the main windows. This indicates that there is air penetrating the outer storm window.
 - Cobwebs were observed moving between the panes during the BD test that supports this.
- The windows located at the first level at the right side set at grade.
 - Consider installing a well, or replacing the lower part of the window with glass blocks, and an operable type at the upper portion.
- There is deteriorated trim at the exterior at the widows at the right side.

- **This improvement also contributes towards the overall leakage reduction by replacing the existing storm windows and installing Quanta Insulated Glass panels at the exterior side.**

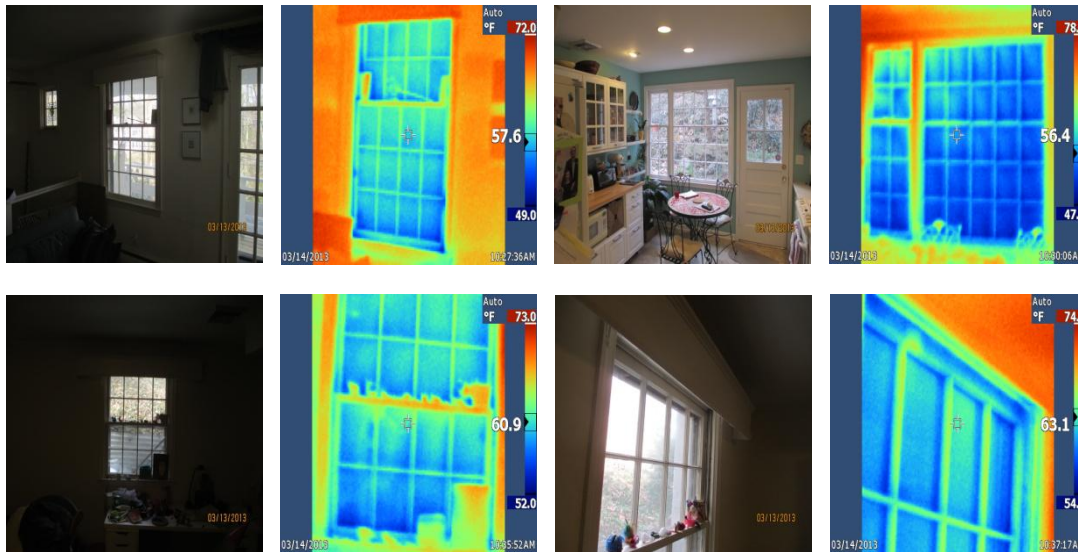
TI's showing examples of infiltration and loss.

- Leakage was observed at most windows during the BD test.
 - Windows at the lower levels are a source of cold air infiltration.
 - Windows located at the upper floors are points of heat exfiltration.

- **All windows should be properly caulked at both the inside and exterior regardless of selected replacement.**

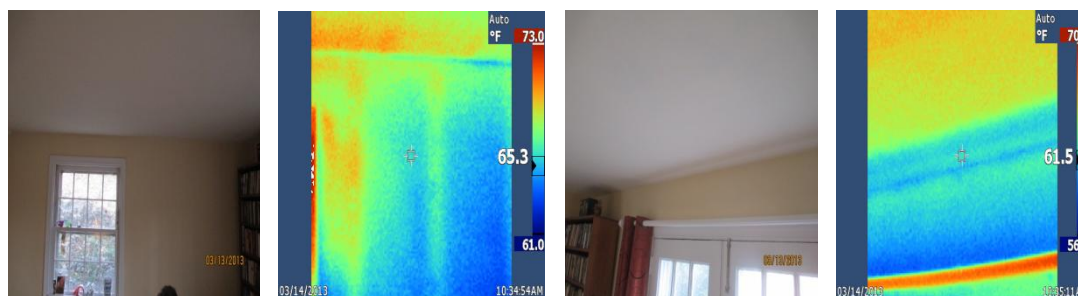
Exterior wall at lower floor elevations and TI at same location.

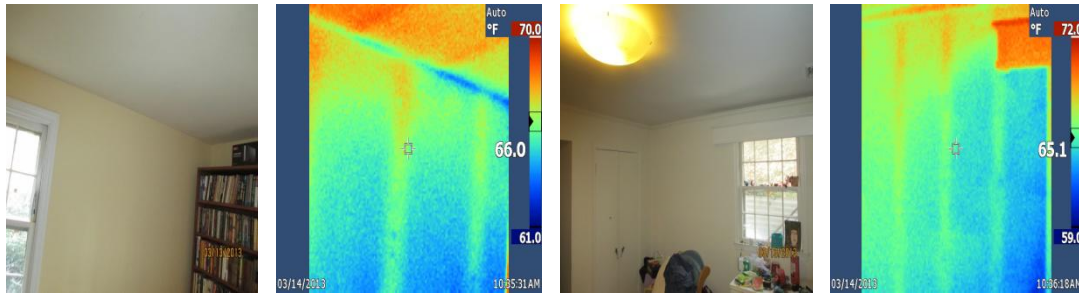
Exterior wall and TI at same location.

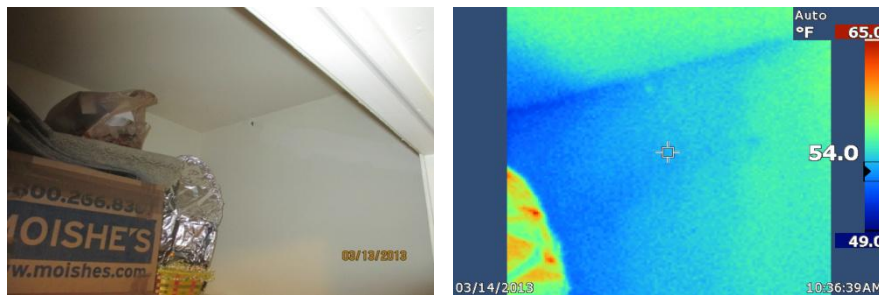
Exterior walls at and TI at same location.

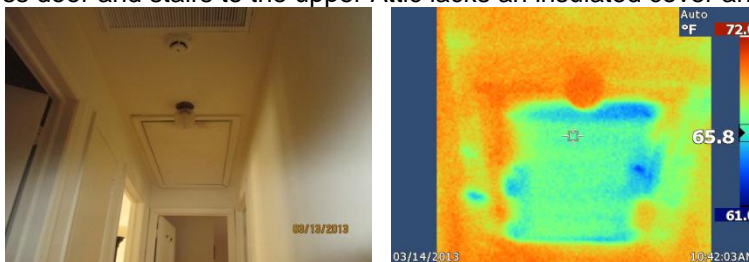
- **Completing the remaining Air sealing recommendations at this space MUST be completed prior to improving the insulation in order not to undermine its effectiveness.**
- Insulation was missing or observed as "black" at locations adjacent to remaining unsealed joints at exterior top plates, top plates and unsealed parts of the bottom at the vertical transition wall that connects the 2 levels, and unsealed duct, etc penetrations as a result of being displaced or dirt being deposited via air flow.
- The drop down access door and stairs to the upper Attic lacks an insulated cover and a tight seal.

Loss at access stairs.

- All insulation must be in contact with the ceiling below and remain loose and not compressed to achieve best performance.
- **The drop down stairs should be fitted with an insulated cover constructed out of 2" closed cell rigid board, or a pre-manufactured type that can easily be lifted out of the way during entry.**

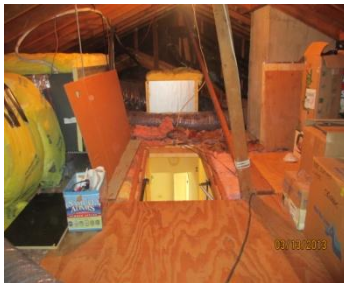
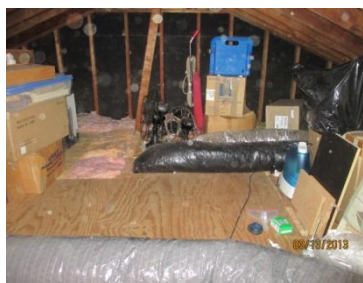
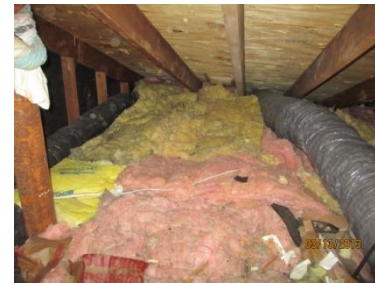
- The Attic floors are constructed of 2x6 joists at 16” on center.
- Some of the upper Attic is used for storage and is covered with plywood deck adjacent to the drop down access stairs that also accommodates an air handler.
- Half the floor (350 SF) at the upper level is insulated with 9” fiberglass compressed into the 6” cavities and is in fair condition.
 - The overall weighted average effective R value of the insulation is estimated to be R16.
- The other half (364 SF) with 5”-6” of mixed loose rock wool and fiberglass.
 - The overall weighted average effective R value of the insulation is estimated to be R15.

Storage deck and conditions at upper Attic.

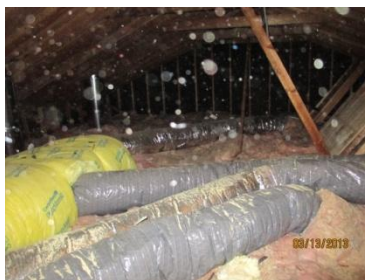
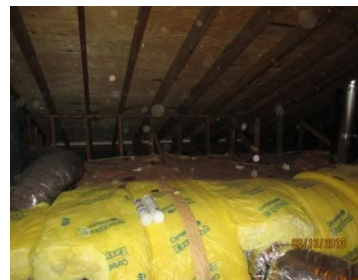
- The insulation at the lower attic is 2"-3" mixed loose rock wool and fiberglass covered with 6" rolled fiberglass on top of it.
 - The overall weighted average effective R value of the insulation is estimated to be R23

Conditions at lower Attic.

- **The UA Average of the 3 different values across the total area is R20.**
 - This is less than the recommended minimum of R38 - R40 for this region.
- The vertical wall connecting the 2 different levels is insulated with 2" of rigid board.

- **The predicted savings are based on increasing the level of insulation to a minimum of R40-R44 by:**
 - Replacing, or supplementing the existing loose insulation with new insulation as follows:

- 11"-14" loose cellulose to R40 – R51.
 - 15" – 16" loose fiberglass to R42 – R45.
 - Consult with product manufacturer or Contractor about the need for a vapor barrier with these products.

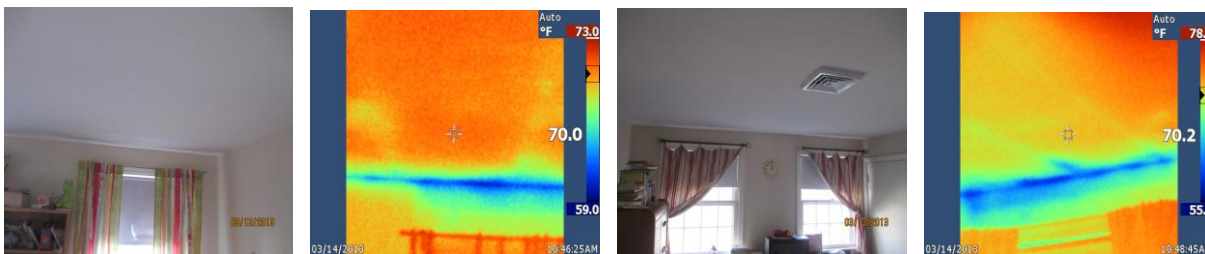
- Thermal images indicate loss at unsealed exterior top plates connected to the attics.
- Black insulation was observed at exterior top plates and some unsealed penetrations indicating that dirt and fines are being deposited in the material as air is passing through it.

Thermal images indicate loss at exterior top plates at upper attic.

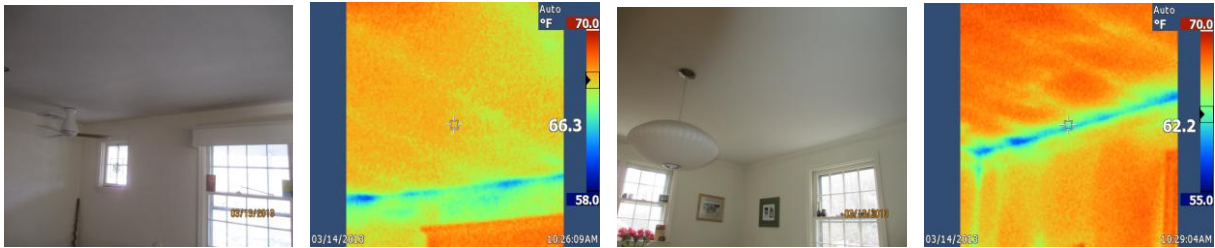
Thermal images indicate loss at exterior top plates at lower attic.

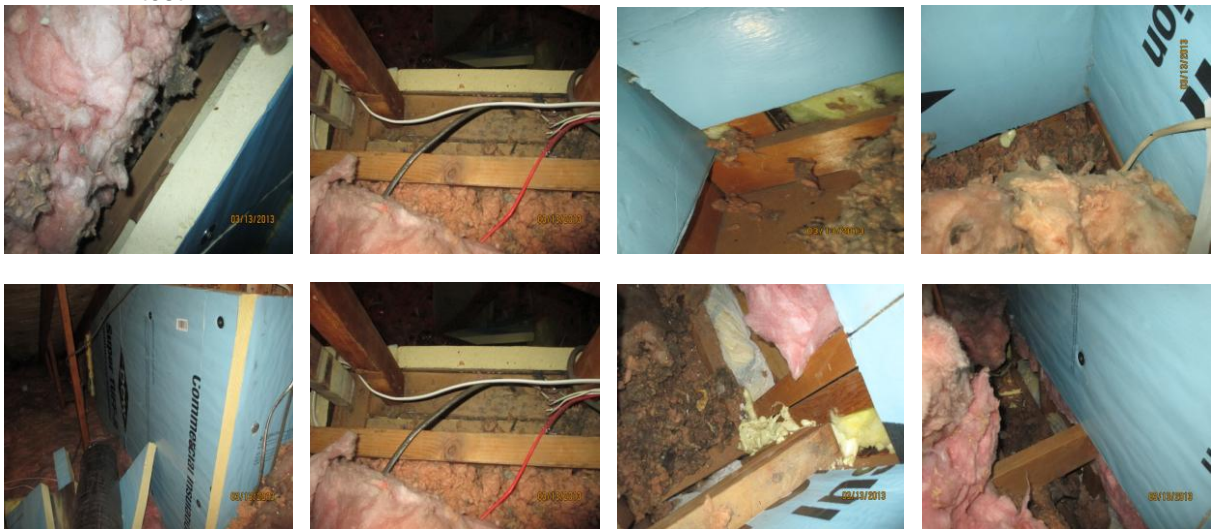
- The vertical wall that connects the 2 levels has been sealed with 2" rigid board, but the top plates are not sealed, there are breaks at the bottom perimeter and unsealed joints, and there is a large by pass where this wall intersects with the drop soffit located in the Kitchen.
 - Significant leakage was observed at the recessed lights in and adjacent to this area during the BD test.

Unsealed top plates, joints, and breaks in the vertical wall at Kitchen soffit connecting the 2 attics.

- Seal all top plates and applicable penetrations at the vertical transition wall.
- Seal the open top of the Kitchen soffit with closed cell rigid insulation board, and seal (infill where missing) any open parts of the vertical transition wall with 2” rigid board and seal the joints with foam.

- Infill any missing locations at the bottom of the vertical wall, and seal all joints at the existing rigid board with UL cold weather tape and/or foam.

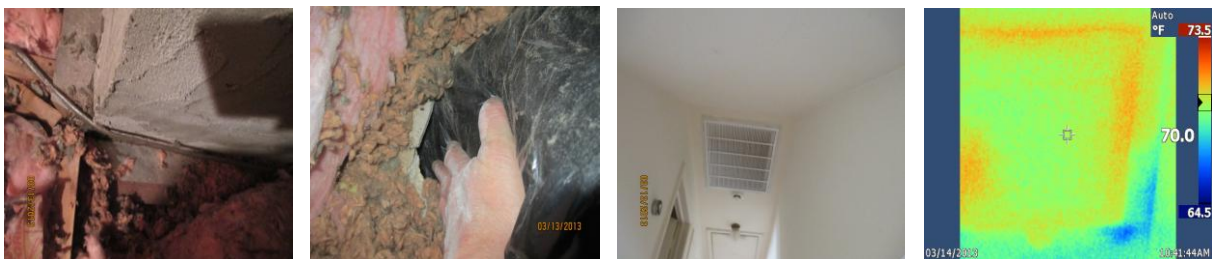
- Leakage was observed at the attic access, recessed lights, some duct, and exhaust fan penetrations during the BD test.

Examples of unsealed chimney and duct penetrations and TI showing example of loss at a RA vent.

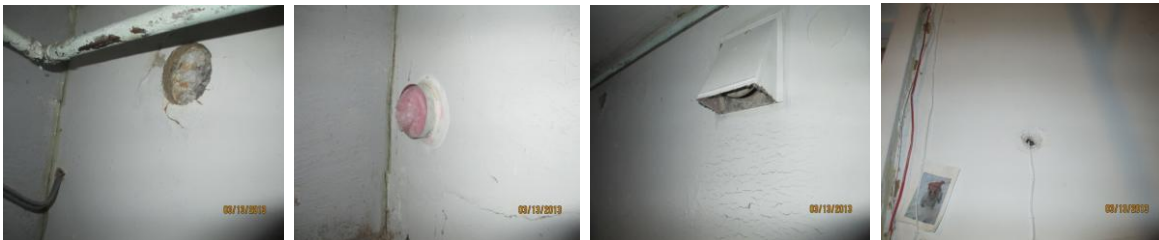
- The wall between the spaces is insulated with loose fiberglass in the cavities (does not appear to be dense packed), but the bottom perimeter joint at the conditioned side is not sealed.
- The floor above the Garage is insulated with loose fiberglass (does not appear to be dense packed), but there are some unsealed penetrations
- There are also several unsealed penetrations thru the wall for wires, abandoned ducts, etc, and gaps in the drywall at the closet that is connected to the wall and abandoned ducts.
 - Also refer to the following Miscellaneous Air sealing section for photos and information regarding issues in the closet as well as the door to the Garage.

Examples of joints and penetrations that need sealed in the wall connected to the Garage or in the Garage ceiling.

- Prepare surfaces by cleaning and removing loose dirt, etc (vacuum).
- Seal all penetrations and joints with closed cell foam or silicone based caulk.
- Seal with foam and/or cap the abandoned metal ducts through the wall.

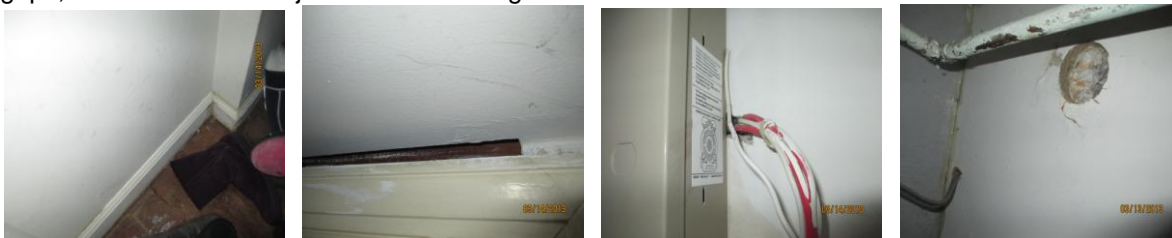
- At baseboards at the Garage wall at the entry foyer, at holes, gaps, and penetrations in the wall, and at gaps, etc at the closet adjacent to the Garage wall.

Examples of unsealed penetrations at Garage wall, baseboards, and gaps at closet door trim.

- Seal penetrations, gaps, and baseboards with foam, joint compound, or silicone based caulk.
- At the joints at the stone above the front entry door wall, and at the joint at the stone ledge next to the planter by the stairs up to the first level.
 - Seal with silicone based caulk.
- At joints at the treads and risers of all stairs to the different levels.
 - Seal with clear silicone caulk.
- At the perimeter ceiling joints and penetrations at the Laundry area, and the joint around the chimney.
 - Leakage at these areas originates at the concealed perimeter band joist.
- At pipe penetration and baseboard at Laundry sink.

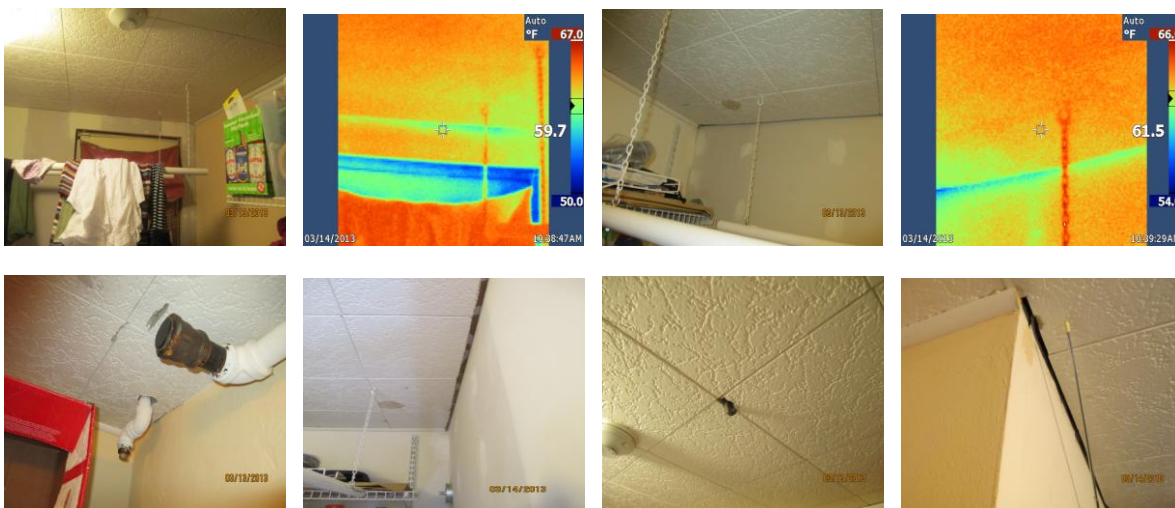
Examples of infiltration and loss at unsealed joints and penetrations in the Laundry area.

- Seal all penetrations with foam or silicone based caulk.
- At most windows throughout.
 - Also refer to the Window Improvement section regarding the installation of Quanta Insulated panels.
 - Remove deteriorated caulking, prepare/clean joints, and apply new silicone based caulk.
- At the perimeter of the front entry, both glass doors to the deck, rear doors to the exterior, and door to the Garage.

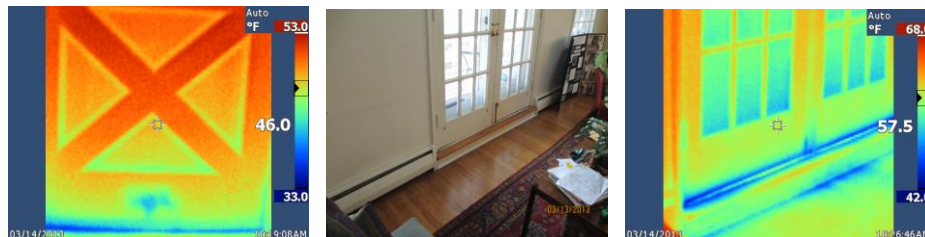
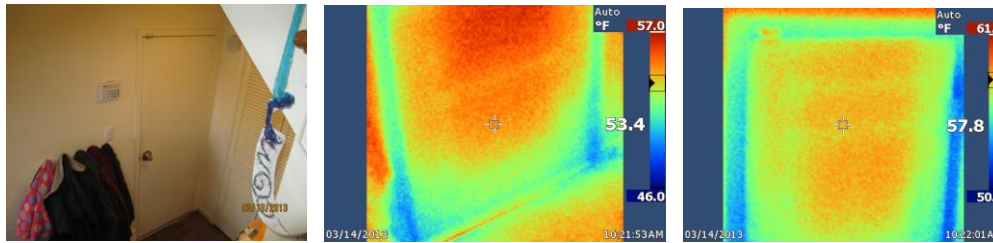
Examples of infiltration and loss at exterior doors.

- Replace all deteriorated weather-stripping and bottom seals.
- Seal all joints at the steps at the glass French doors to the deck and front with silicone based caulk.
- Also refer to the Exterior Door Replacement section.
- At the abandoned radiator at base of wall in the Home Office and at the joints at the step to the door.
 - Seal with silicone based caulk.
- At the baseboard and pipe penetration for the sump pump in the rear BR closet.

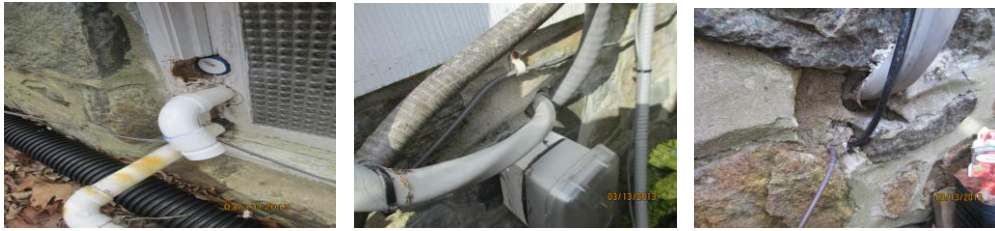
Examples of deteriorated seals at penetrations.

- Remove deteriorated caulk as applicable and re-caulk penetrations, or seal with foam and/or caulk poorly or unsealed penetrations and perimeter window joints with exterior grade silicone based caulking.

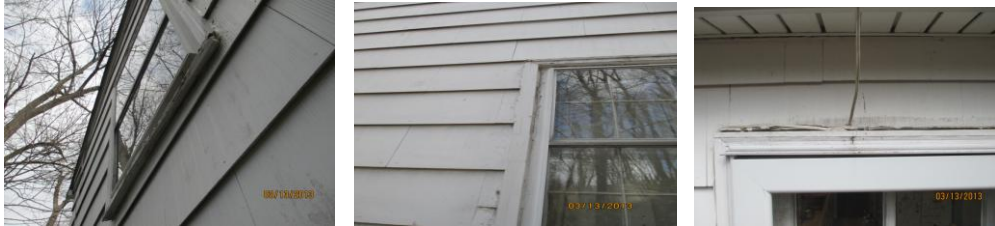
Examples of deteriorated caulk at windows.

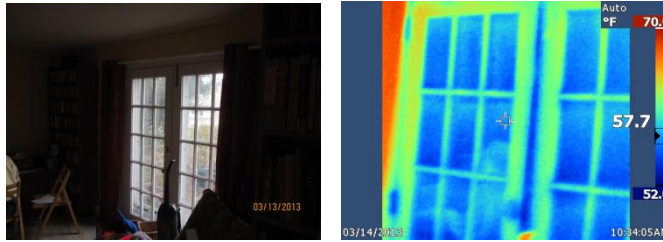
- The two double glass doors with outer storm doors at the Home Office and to the front deck at the mid level are exposed to cold northerly winds and are a source of cold air infiltration.

Infiltration and loss at glass doors at Home Office.

- **Budgeting to replace the double door to the exterior at the lower level Home Office, and the 2 rear doors to the exterior from the lower and mid levels is recommended to eliminate infiltration and loss at these locations.**

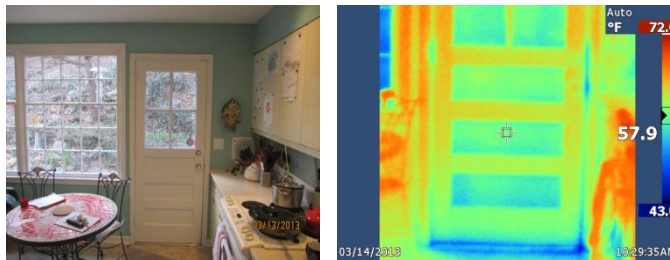
- The exterior door to the rear from the Kitchen is a poorly insulated solid wood panel type in poor to fair condition, has a large single pane glass window, a storm door, and has poor weather-stripping.
 - Thermal images indicate that this door is a source of cold air infiltration and loss of conditioned air.
 - This door should be budgeted for replacement in the future.

Kitchen door and TI indicating infiltration & loss.
