CAB50 Additional Seal Locations

If encountering an Eco-Choice CAB50 with low vacuum, additional sealing of the ashpan area, as well as air-shutter adjustment may be needed. The figures below show where and how to seal these areas and an example of air shutter adjustment. In CAB50 units manufactured after 05-20-2013 the areas at the back of the ashpan will be sealed from the factory, only the pedestal bolt holes may need to be sealed.

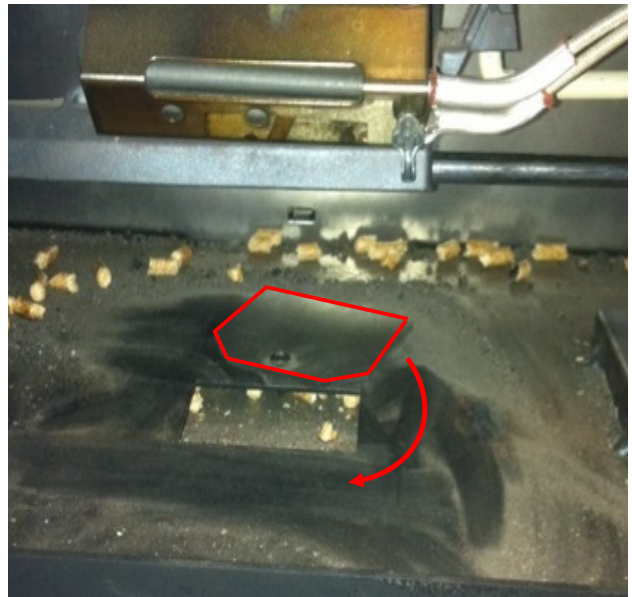
Figure 6

Air Shutter Adjustment (Fig. 6)

To increase vacuum and help to tune out some “rumbling”, the air shutter in the ashpan can be closed down. Once closed, small adjustments are recommended to maintain correct flame appearance and flame height.
