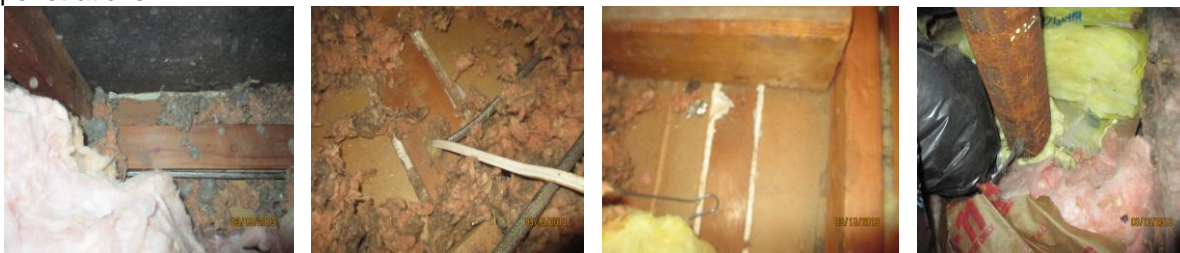
- Overall the attic spaces are reasonably sealed at interior top plates, gable top plates, and many penetrations.

Examples of sealed top plates and penetrations.

- Thermal images indicate loss at unsealed exterior top plates connected to the attics.
- Black insulation was observed at exterior top plates and some unsealed penetrations indicating that dirt and fines are being deposited in the material as air is passing through it.
